Case Report

Partial Obstruction of the Endotracheal Tube by the Plastic Coating Sheared from a Stylet

Anirudha Das, Shwetha Chagalamarri, and Kim Saridakis

Metro Health Medical Center, Cleveland, OH 44109, USA

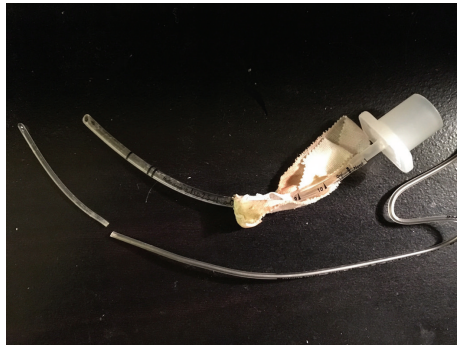
The usual protocols of the unit were followed at the time of intubation. The unusual observation during the process was that the physician had to use more than usual force while pulling the stylet out of the ETT after intubation.

Over the next several hours the child deteriorated significantly in terms of respiratory status. The ventilator setting had to be increased to manage persistent desaturations and retained carbon-dioxide (CO₂). On clinical examination there was diminished chest rise and faint breath sounds. A chest X-ray showed areas of atelectasis of the lungs bilaterally. The child was switched to an oscillator to improve the ventilation but hardly any “wiggle” could be observed over the chest, in spite of increasing the amplitude. Finally, a decision was made to reintubate the infant. When the ETT was pulled out, the reason behind the deteriorating respiratory status was established. The plastic tip of the stylet had been sheared off from the aluminum core and was lodged on the distal end of the ETT hardly leaving any space for passage of air. After removal of the plastic piece, the condition of the

FIGURE 1: The sheared off piece of plastic and the stylet alongside the endotracheal tube.

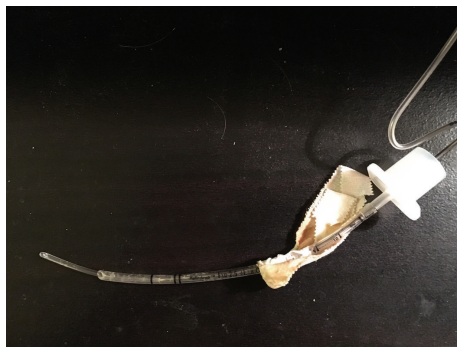
FIGURE 2: The orientation of the stylet along with the piece of plastic within the endotracheal tube, at the time of intubation.

This case demonstrates that application of excessive force while taking the stylet out after intubation could lead to shearing and lodging of the plastic sheath in the lumen of the ETT. Though this is a rare occurrence, this mechanism of mechanical obstruction of the ETT should be kept in mind while taking care of intubated infants in the NICU.
